MARINE INVESTIGATION REPORT
M04N0086

CAPSIZING AND LOSS OF LIFE

SMALL FISHING VESSEL *RYAN'S COMMANDER*
5 NAUTICAL MILES EAST OF CAPE BONAVISTA,
NEWFOUNDLAND AND LABRADOR
19 SEPTEMBER 2004

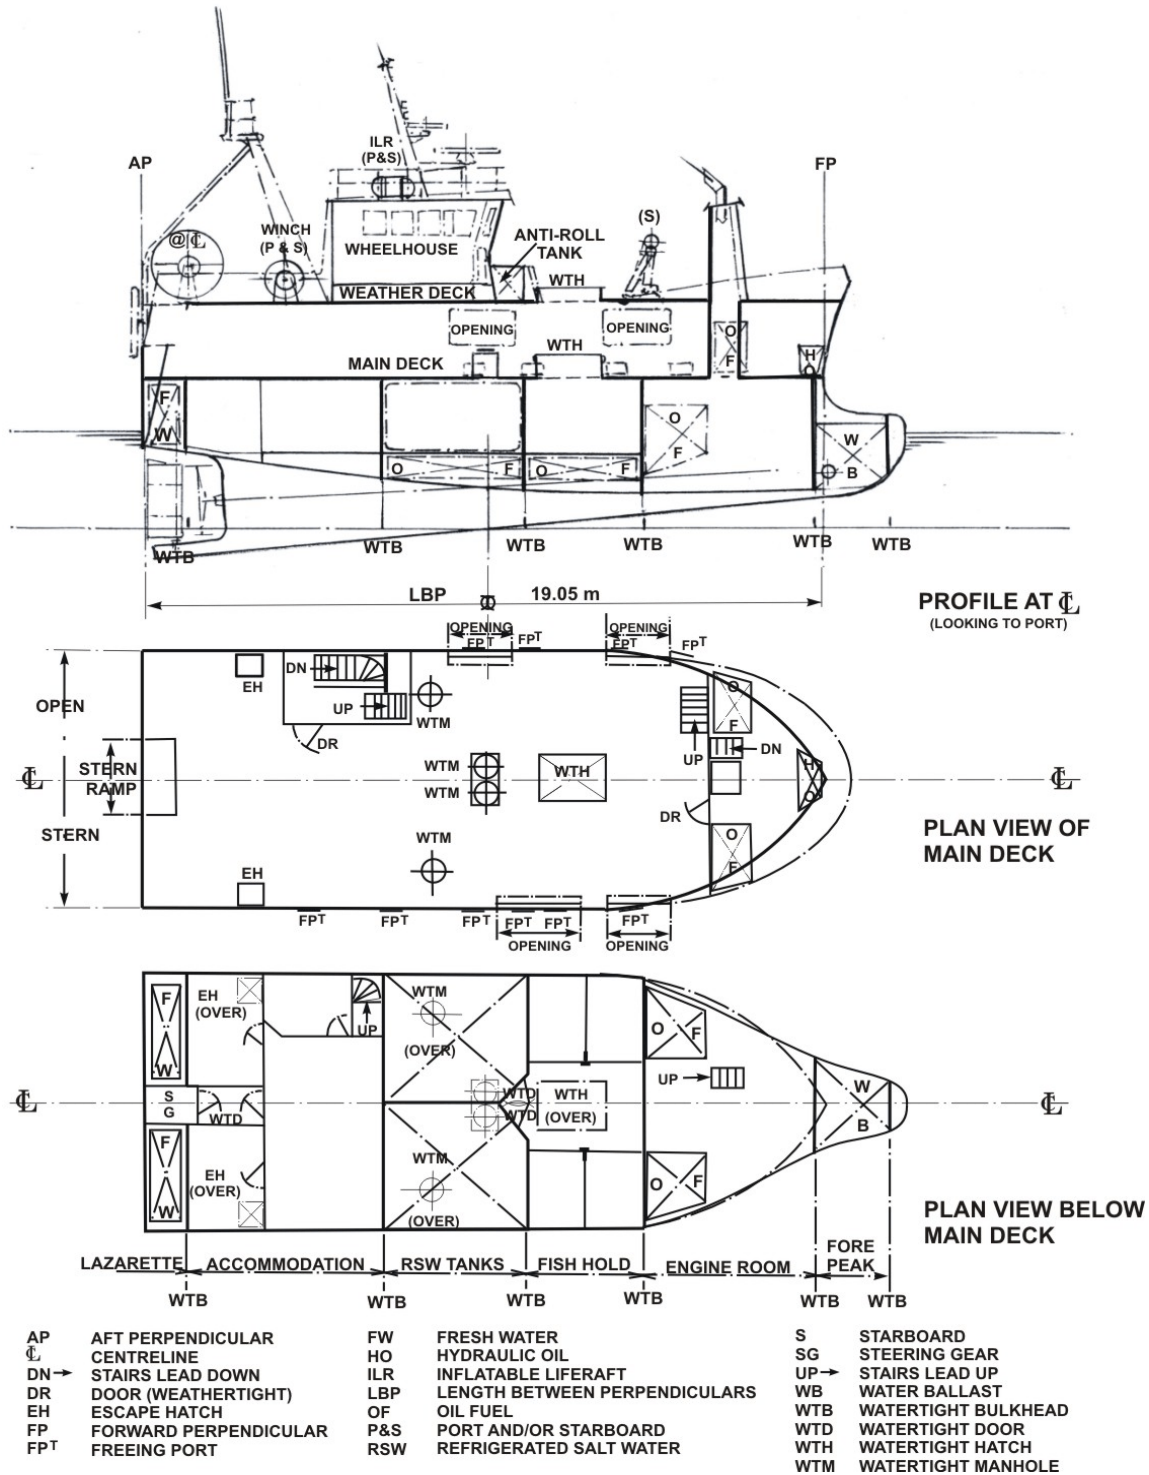
Appendix A – General Arrangement Plan of the Ryan’s Commander

On 15 January 2004, the general arrangement for the *Ryan's Commander*, as submitted, was approved subject to notations in red by the TC technical office in St. John's. Approved copies of this plan were sent to the NA, TC Headquarters in Ottawa, Ontario (for retention purposes only), and the TC district office in Lewisporte, Newfoundland and Labrador, with a copy retained by the St. John's office. This plan with covering letter was then forwarded by the NA to the builder. The ART plan had not been returned by TC to the NA at the time of the occurrence. The diagram below represents relationships (contractual and otherwise) between the owners, builder, NA and TC.

3. The decision not to conduct a formal inclining experiment ran counter to the condition on the Transport Canada (TC)-approved general arrangement plan and meant that the vessel's stability characteristics were neither fully assessed nor fully understood by the owners, the builder, the naval architect or TC.

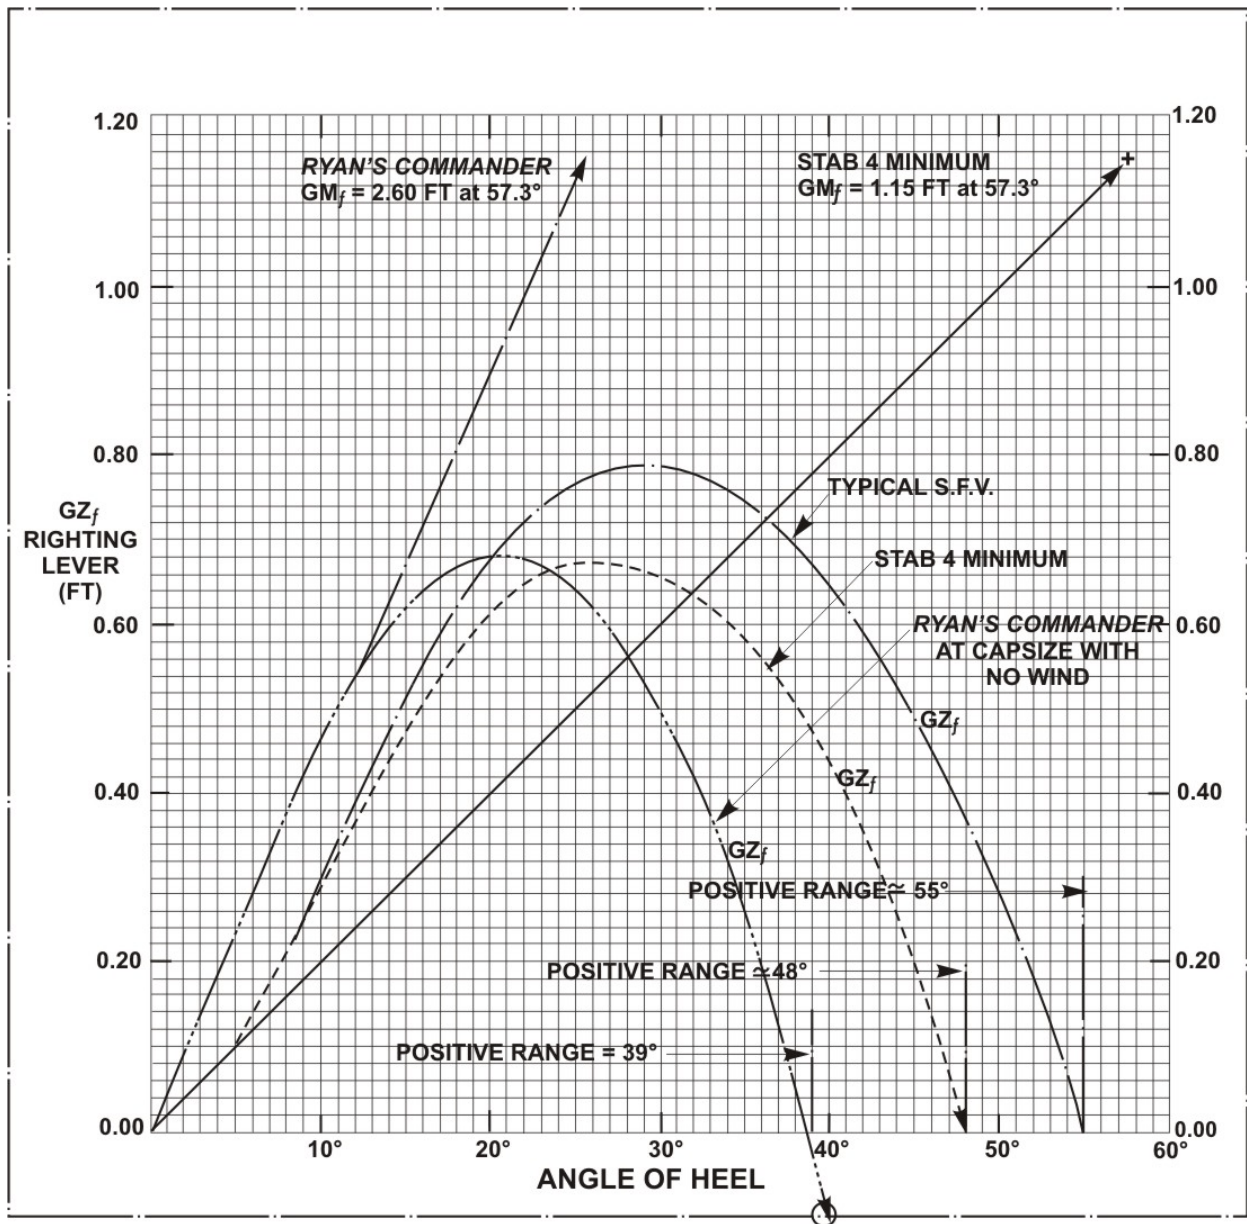
Appendix C – Comparison of GZ Curves for the Ryan's Commander, STAB 4, and a Typical Small Fishing Vessel

The results for the loading condition at the time of capsizing (with water ballast, the ART in use, and no wind) show that the vessel did not meet most STAB 4 criteria. Its stability beyond 30° is about 34 per cent of the criteria, and the maximum GZ occurs at 20° rather than the minimum 25° recommended in STAB 4. Furthermore, the vessel's range of positive stability is limited to a maximum of 39° while the STAB 4 typical range is about 48°, and angle ranges greater than 50 to 55° are generally to be expected for typical SFVs of this size (see Appendix C).

During the voyage, the lightly loaded vessel's range of positive transverse stability was below the minimum criterion of STAB 4 and what is generally expected for typical SFVs of this size (see Appendix C). The steady wind-induced heel of 7° to port, together with its range of positive transverse stability to not more than 35°, further reduced the vessel's power of recovery on that side. The situation was further compounded by the dynamic effects of beam and quartering seas, which caused significant fluctuations in trim and stability characteristics.
